Illicit Discharge Investigation Report

Case Number: 100330

Location: 1711 1st St., SW (Super Salvage, Inc.)

Date of Investigation: March 30, 2010

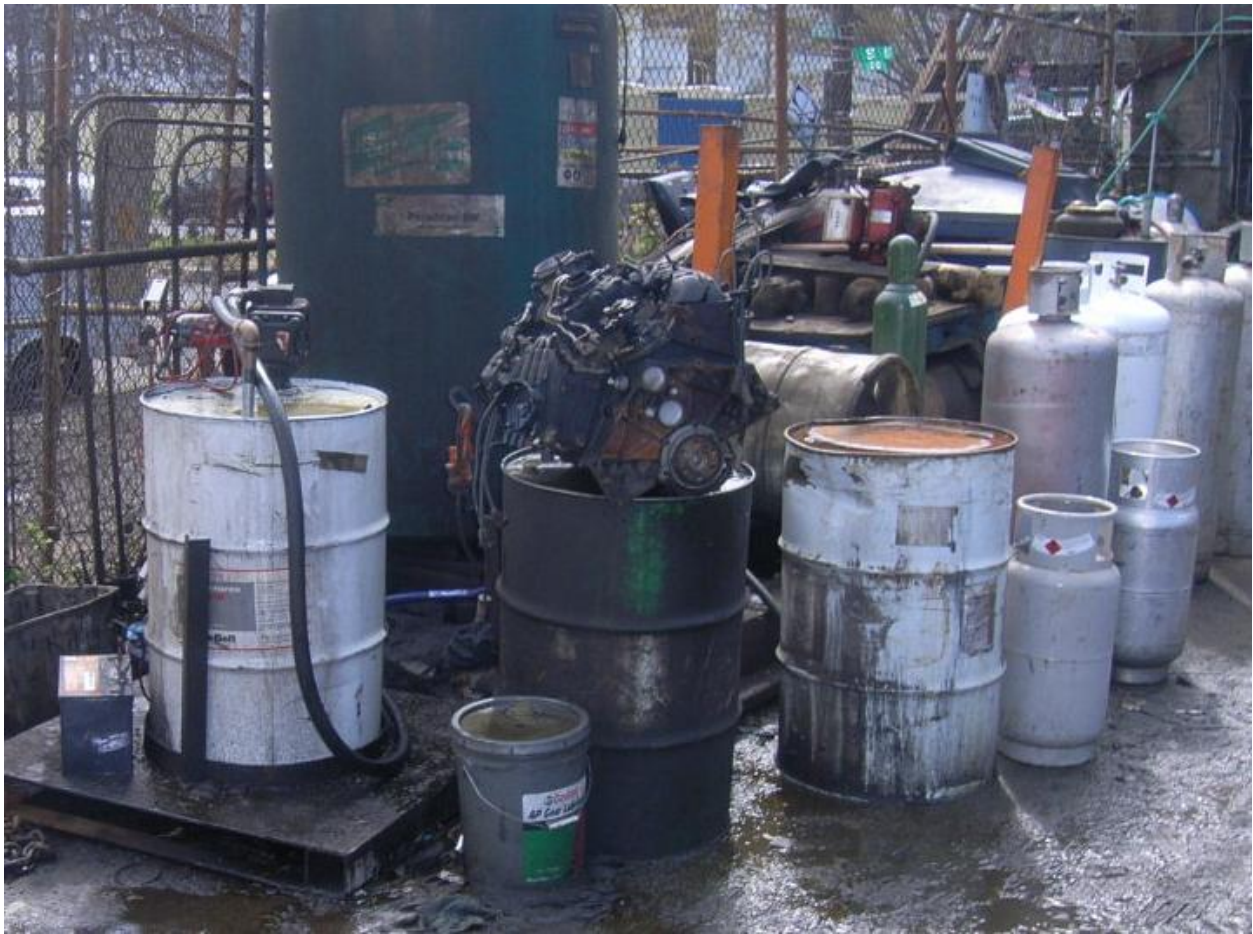
Waste material storage at 1711 1st St., SW

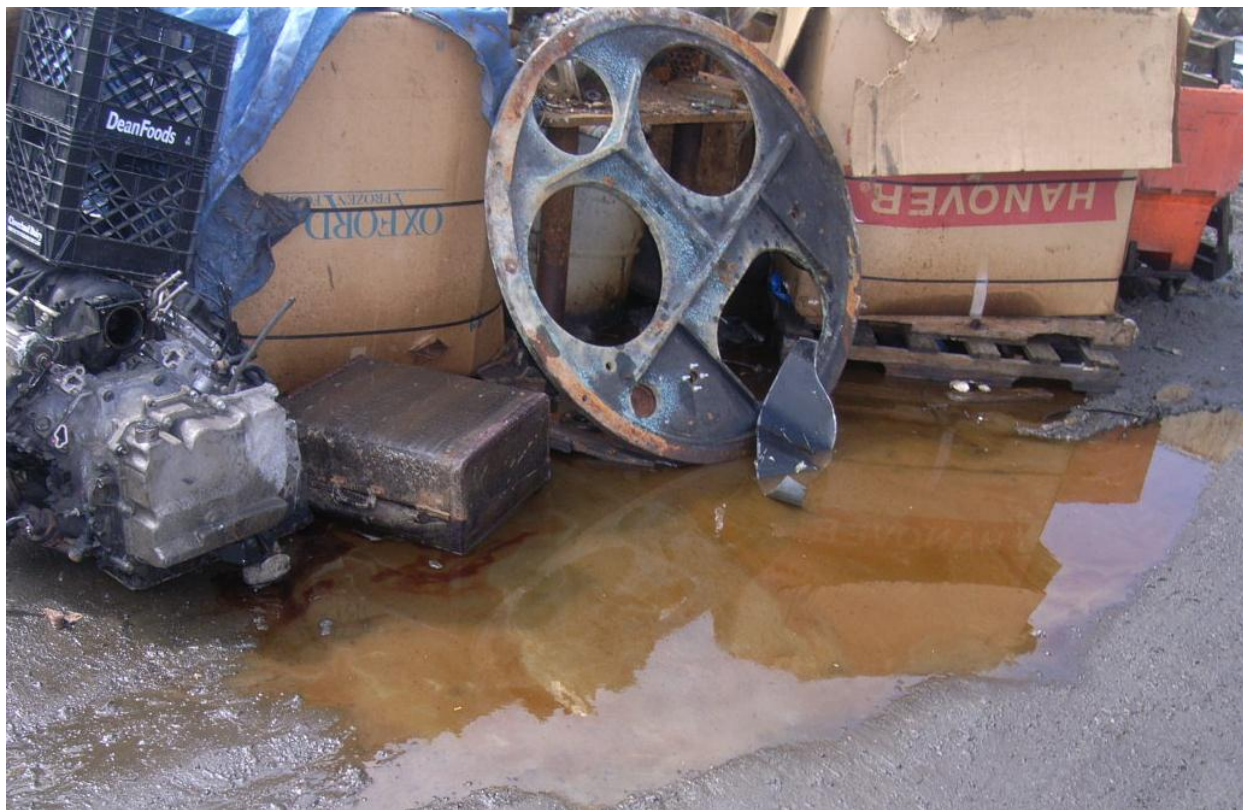
Inspectors noticed various types of fluids leaking from storage boxes left on the grounds of the property, automotive parts, and also from buildings on the property. Upon asking why fluids were coming out of the buildings, inspectors were told that they had a malfunction with the hydraulic equipment the day prior, and they are working on fixing that problem. During the time of inspection, the hydraulic equipment was turned off. Inspectors also noticed what seemed to be a concrete hole in the ground. Mr. Bullock told inspectors it was used for collecting runoff fluids on the property. Mr. Bullock stated that this "runoff collection unit" is later pumped into the pond of the back of the building. An employee on site disagreed with Mr. Bullock and said that contractors came to pump liquids from the concrete hole, and that it was a closed catchment system. When asked to see documentation that such fluids are been picked up, Super Salvage was unable to locate the paper work.

Storage boxes leaking of fluids at 1711 1st St., SW

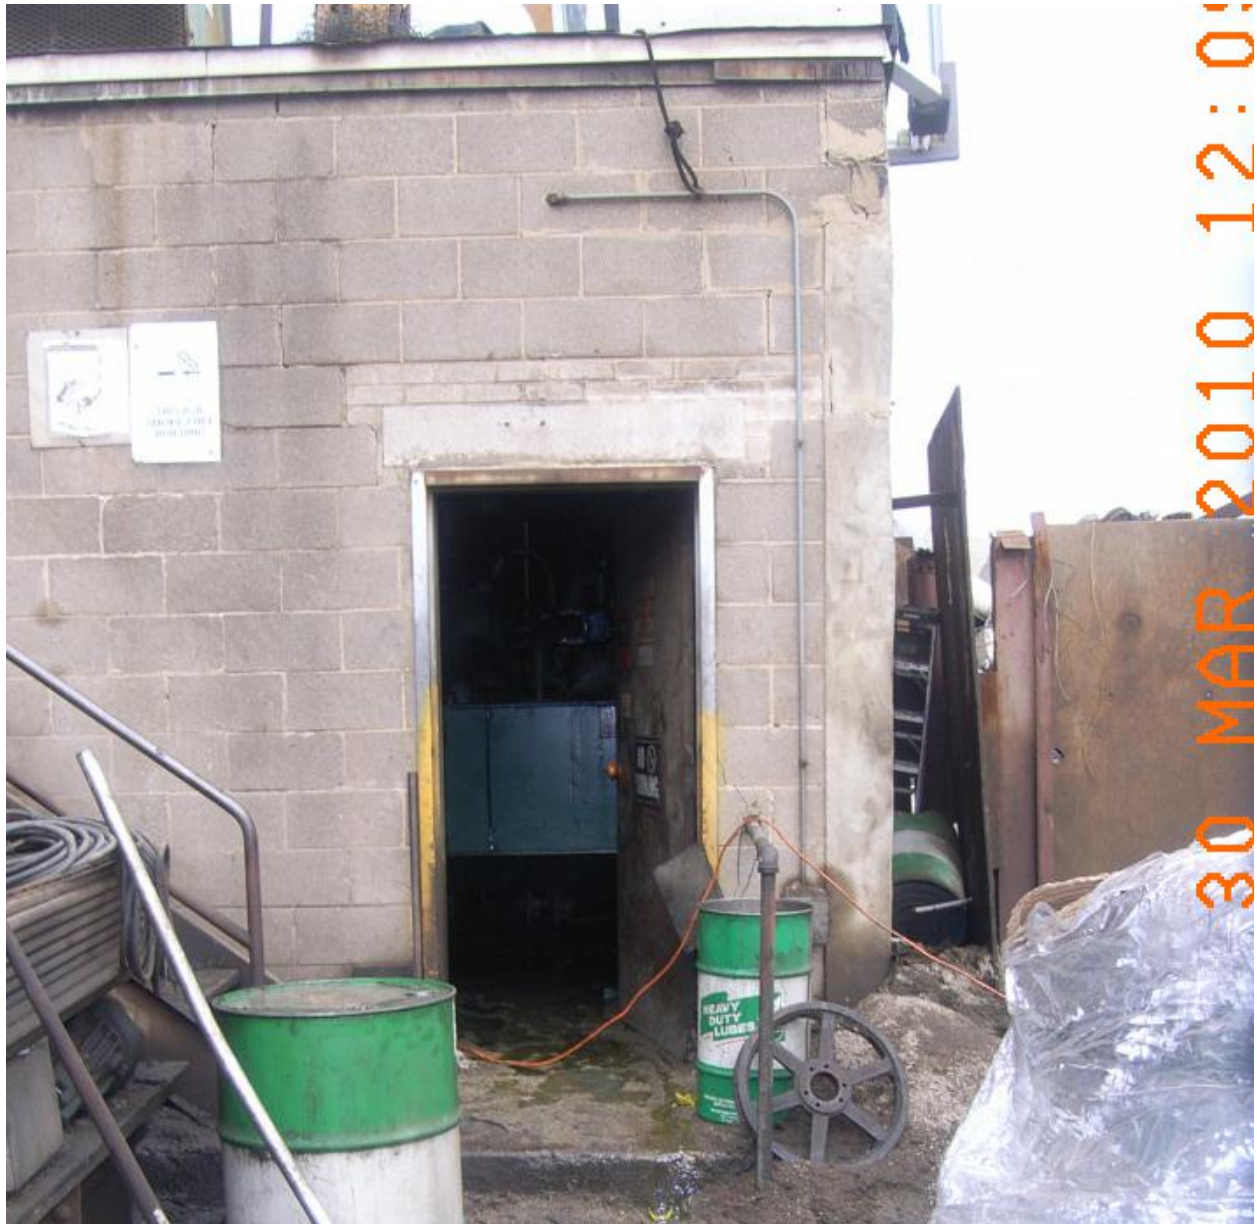
Equipment building with fluids coming out it at 1711 1st St., SW

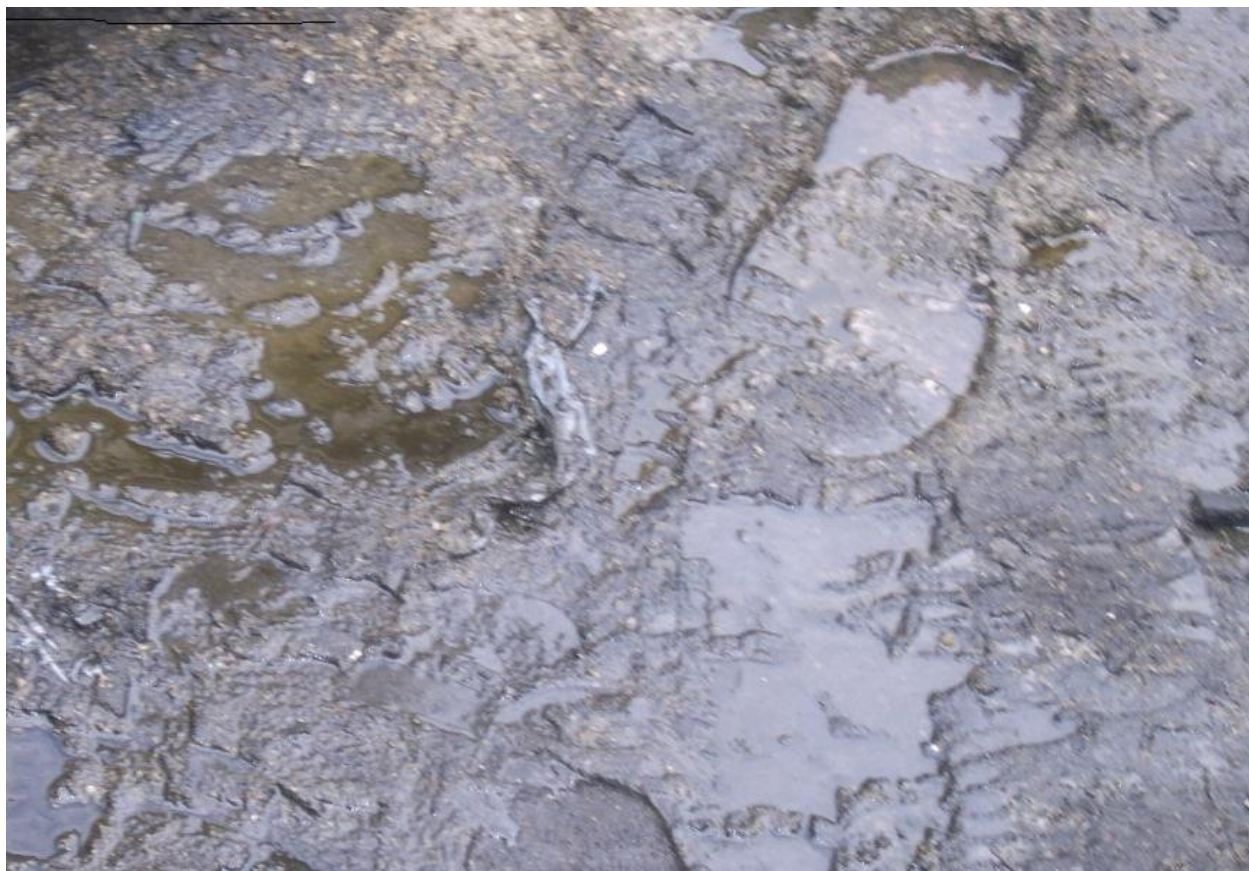
Contaminated soil area at 1711 1st St., SW

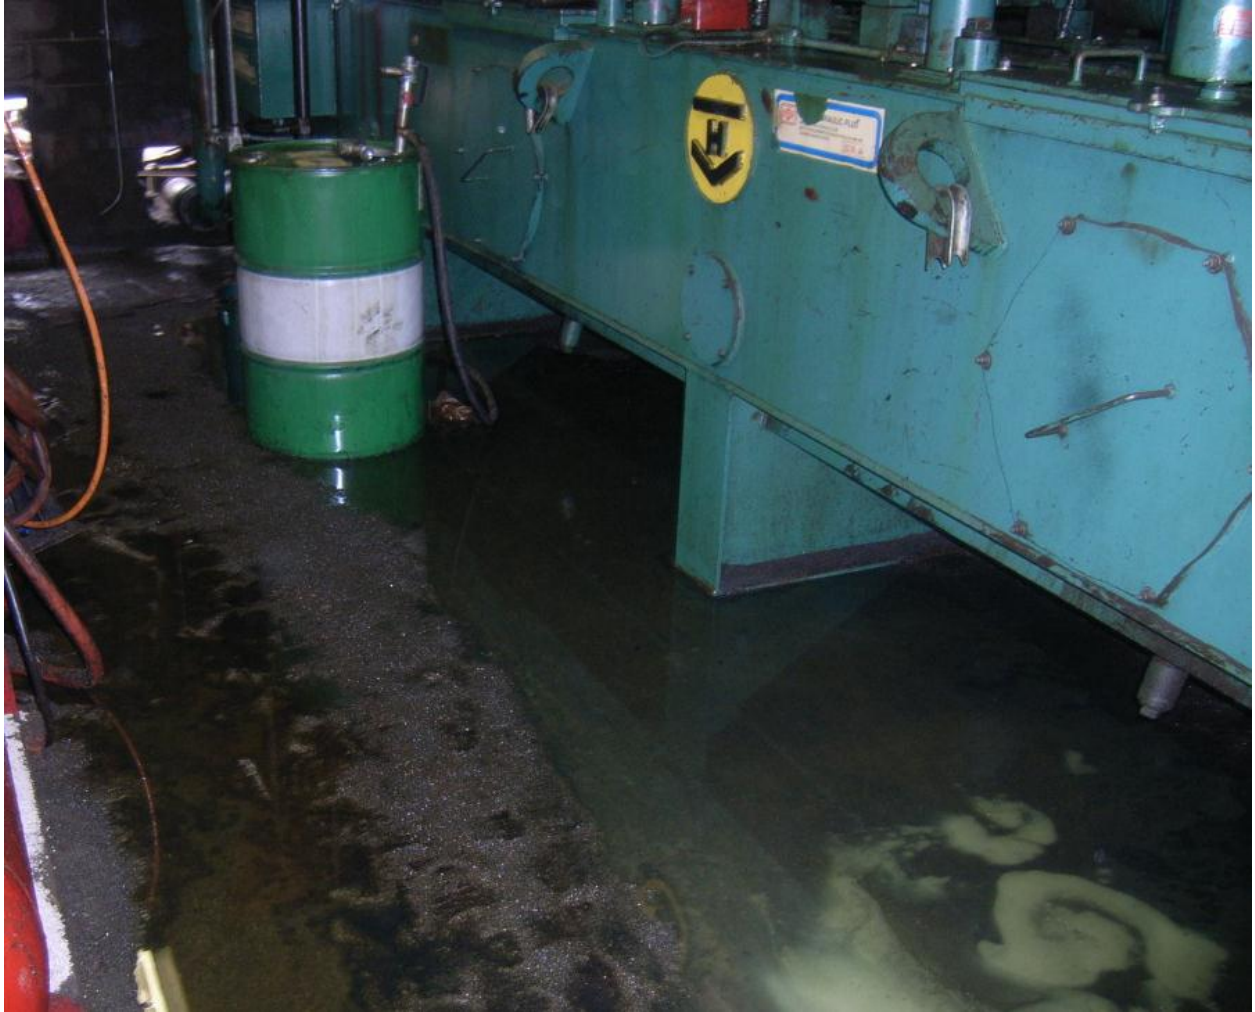
Equipment Building showing fluid on the floor at 1711 1st St., SW

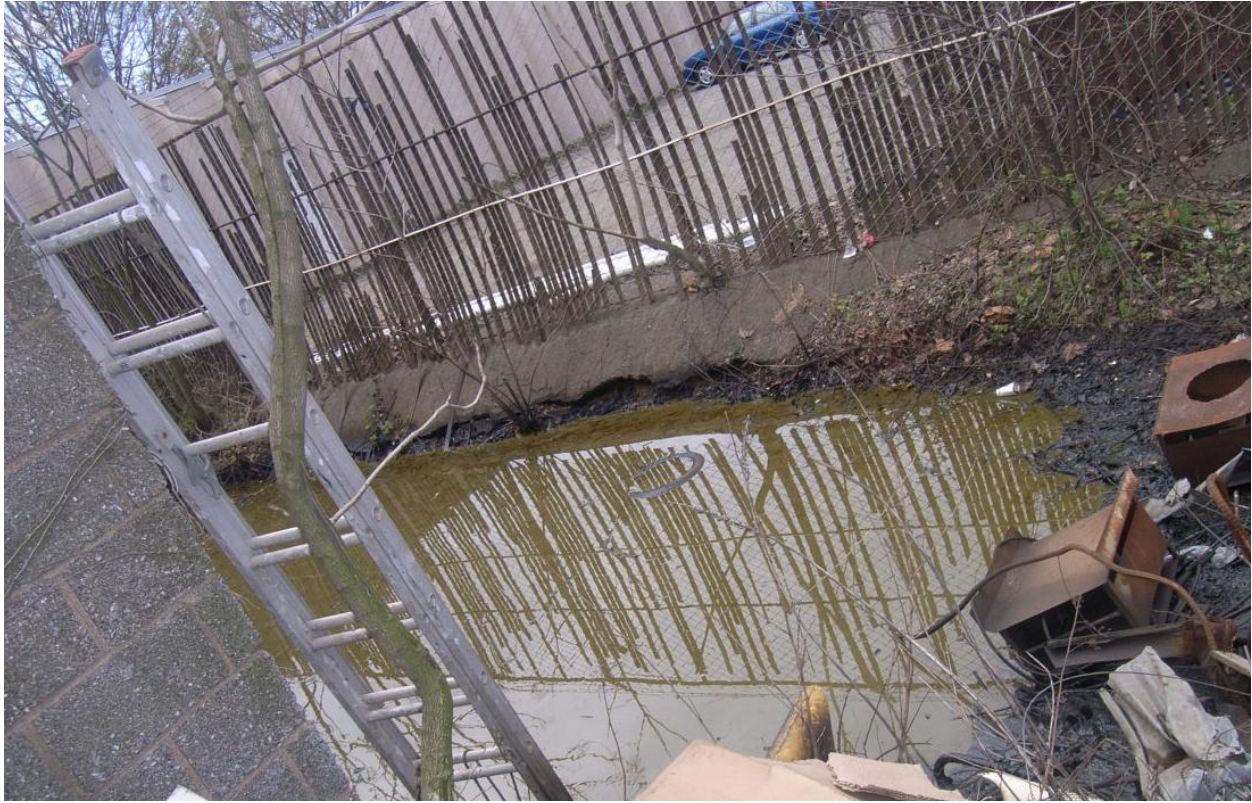
Inspectors also noted a large pond-like structure behind one of the equipment buildings which was filled with a mix of water and various unknown fluids. When asked why such a pond existed, Mr. Bullock stated that for several years they have always pumped such liquids into the hole which they allow to drain into the ground or evaporate. A majority of this property is not paved, and it is also apparent that the operations at this facility have resulted in severe contamination to soil in and around the property.

Hole in the ground with different pumped liquids at 1711 1st St., SW
